Crandall Canyon: Photos paint a grim picture

One depicts damage from a March jolt not reported to MSHA

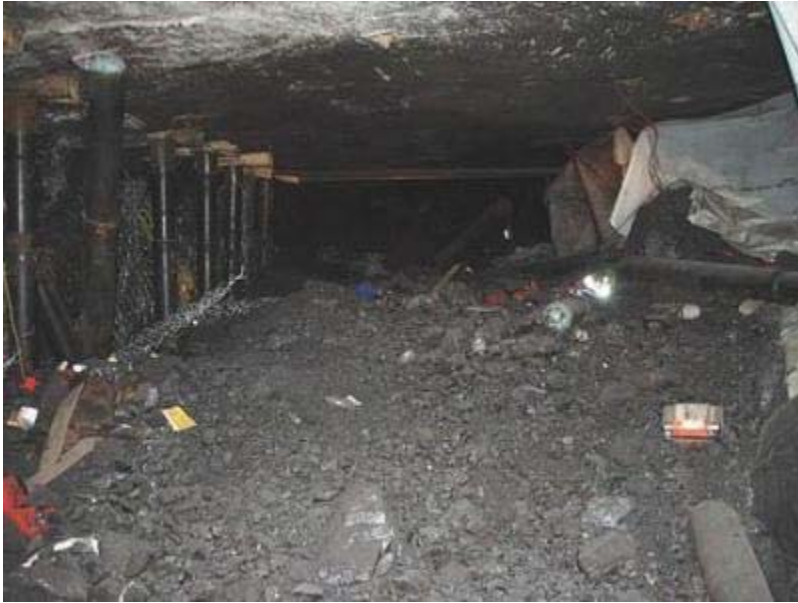
The Crandall Canyon mine tunnel where three rescuers were killed Aug. 16 is littered with chunks of coal that shot out of the mine wall, along with steel and wooden roof support beams, wire mesh fencing and other debris. (Photo courtesy of the federal Mine Safety and Health Administration.)

continuous mining machine used in the rescue effort almost completely buried by the Aug. 16 collapse that killed three miners and injured six.

A third shows the hydraulic water jacks used to support the roof, pushed like aluminum cans into the tunnels by debris that burst from the walls that day.

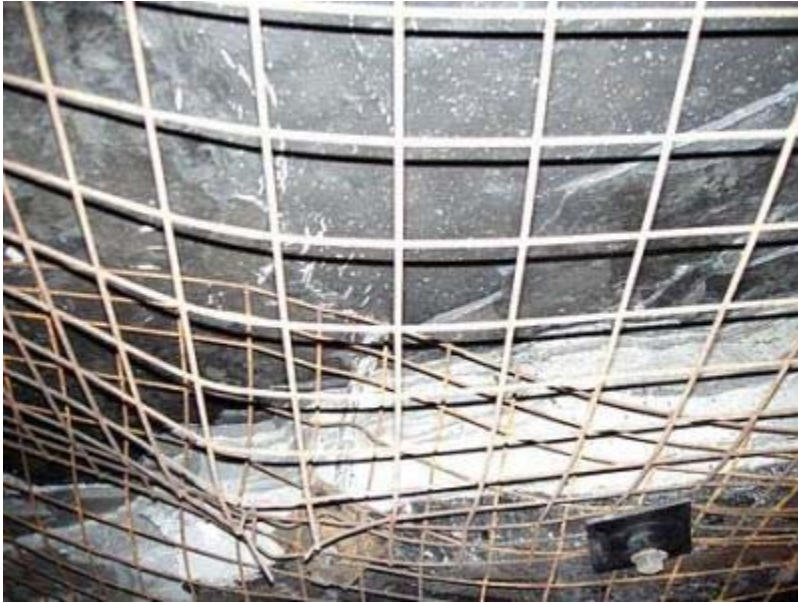
A slab of white sandstone, which used to be above the Crandall Canyon mine's coal seam, pushed down with great force on the wire-mesh fencing that helped hold up the tunnel roof. (Photo courtesy of the federal Mine Safety and Health Administration.)

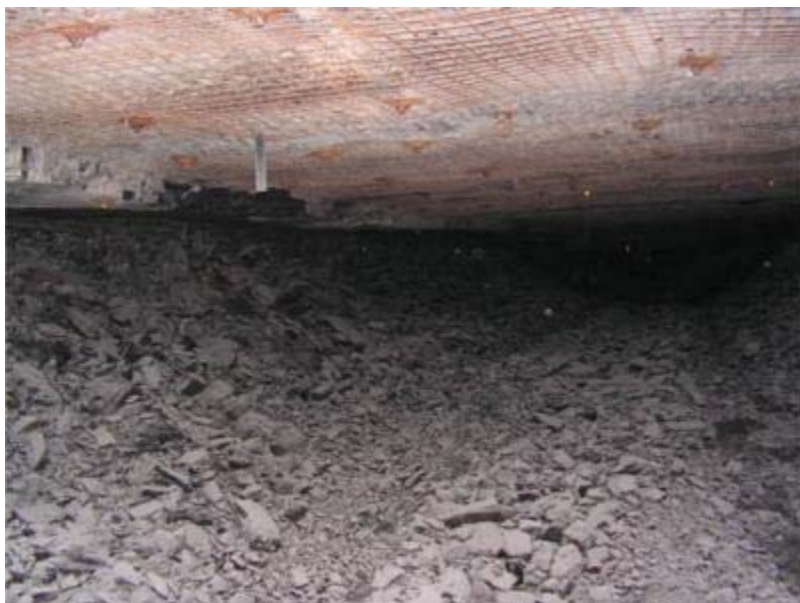
A bump in the Crandall Canyon mine in March filled passageways with mounds of coal and did extensive damage to the mine. This photo was taken by the company after a significant amount of material had already been removed, but it shows the extent of the destruction in the mine. The event was never reported to mine safety officials and a similar event in August killed six miners. The jolt to the mine is part of the Mine Safety and Health Administration's investigation, officials said this week. (Photo courtesy MSHA)

The photograph taken after a March 10 bounce shows heaping piles of coal blocking nearly the entire passageway and was taken by UtahAmerican Energy Inc., the mine operator, after a significant amount of debris had already been hauled away, Gates said.

The company never reported the March event to MSHA. Instead it abandoned its work carving away the thick north barrier, which helps support the mine, and moved to the south barrier. The March bounce occurred about 900 feet from where miners were working at the time of the Aug. 6 collapse.

The company has said that it responded to the March event appropriately. A Bureau of Land Management inspector, Stephen Falk, was in the mine on March 12. He reported that the coal that burst from the pillars had filled tunnels for nearly 200 feet and walls designed to separate the tunnels that circulated air had been damaged for roughly 1,000 feet.
